Technical Report on the Status of the Walkerton Water Supply System

Technical Report

November 2000

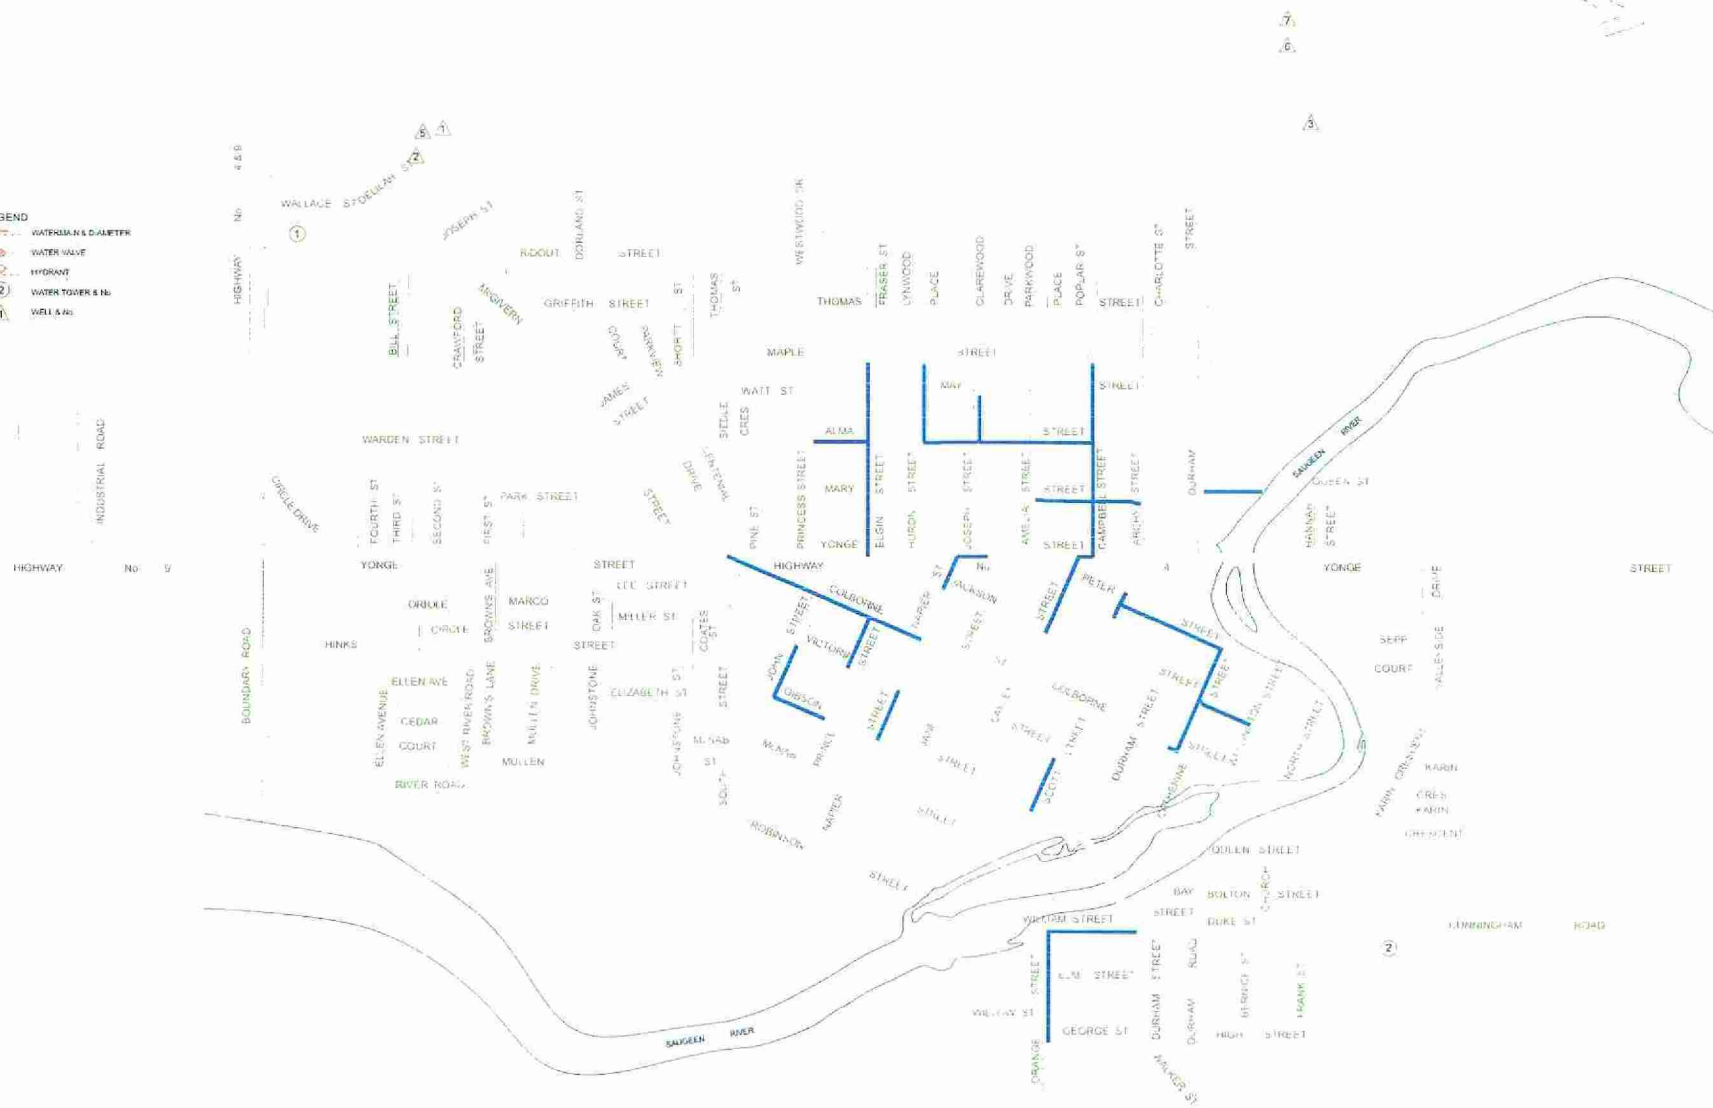
FIGURE 1

As mentioned earlier, all watermains greater than 100 mm were swabbed. Swabbing attempts were made on the 100 mm watermains, but they were found to have a significant build-up of calcium, magnesium and iron carbonate deposits, which prevented effective swabbing. In some areas, this build-up had reduced the effective capacity of these pipes by 50 percent. OCWA's microbiological consultant advised that, while the flushing of watermains less than 100 mm in diameter had effectively cleaned and disinfected those sections, the biofilm contained within the 100 mm pipes could harbour contaminants.

On July 24, 2000, the Ministry ordered the Municipality and the PUC to replace these sections of 100 mm watermain (see Figure 1). Following discussions with the Municipality and the PUC, OCWA arranged for and managed the pipe replacement process. (Reference should be made to Section 9.0 of the OCWA Report for a full description of this work.)

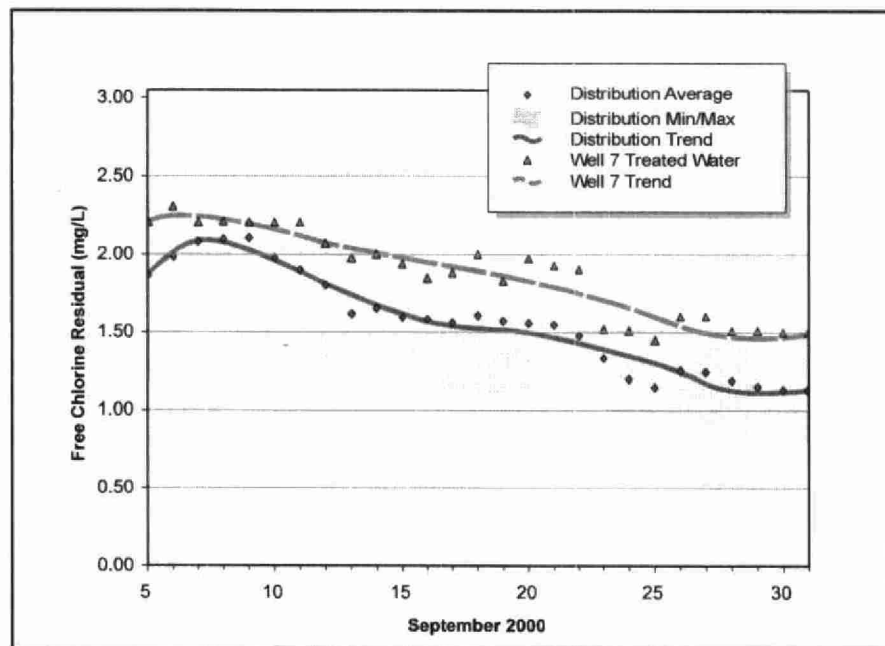
Figure 2: Free Chlorine Residual Trends at Well 7 and in the Distribution System during September 2000

The average free chlorine residual level in the distribution system on September 5, 2000 was 1.9 mg/L. By October 1, 2000, the average free chlorine residual had been reduced to 1.1 mg/L (see Figure 2).

The increase in the chlorine residuals observed at the beginning of September is from the increase in chlorine dosage in response to the adverse results of August 27, 28, 2000 and of September 2, 3, 2000. (For a discussion of the results of August 27, 28, 2000 and September 2, 3, 2000, see Appendix G-2). Once testing from the Distribution System Sampling Program showed no total coliforms or *E. coli* in the system, OCWA again began reducing the chlorine dosage at Well 7. As the dosages at the well were reduced, the free chlorine residual in the distribution system also declined. By the end of the month, the levels had begun to stabilize, with no further adverse results in the distribution system.

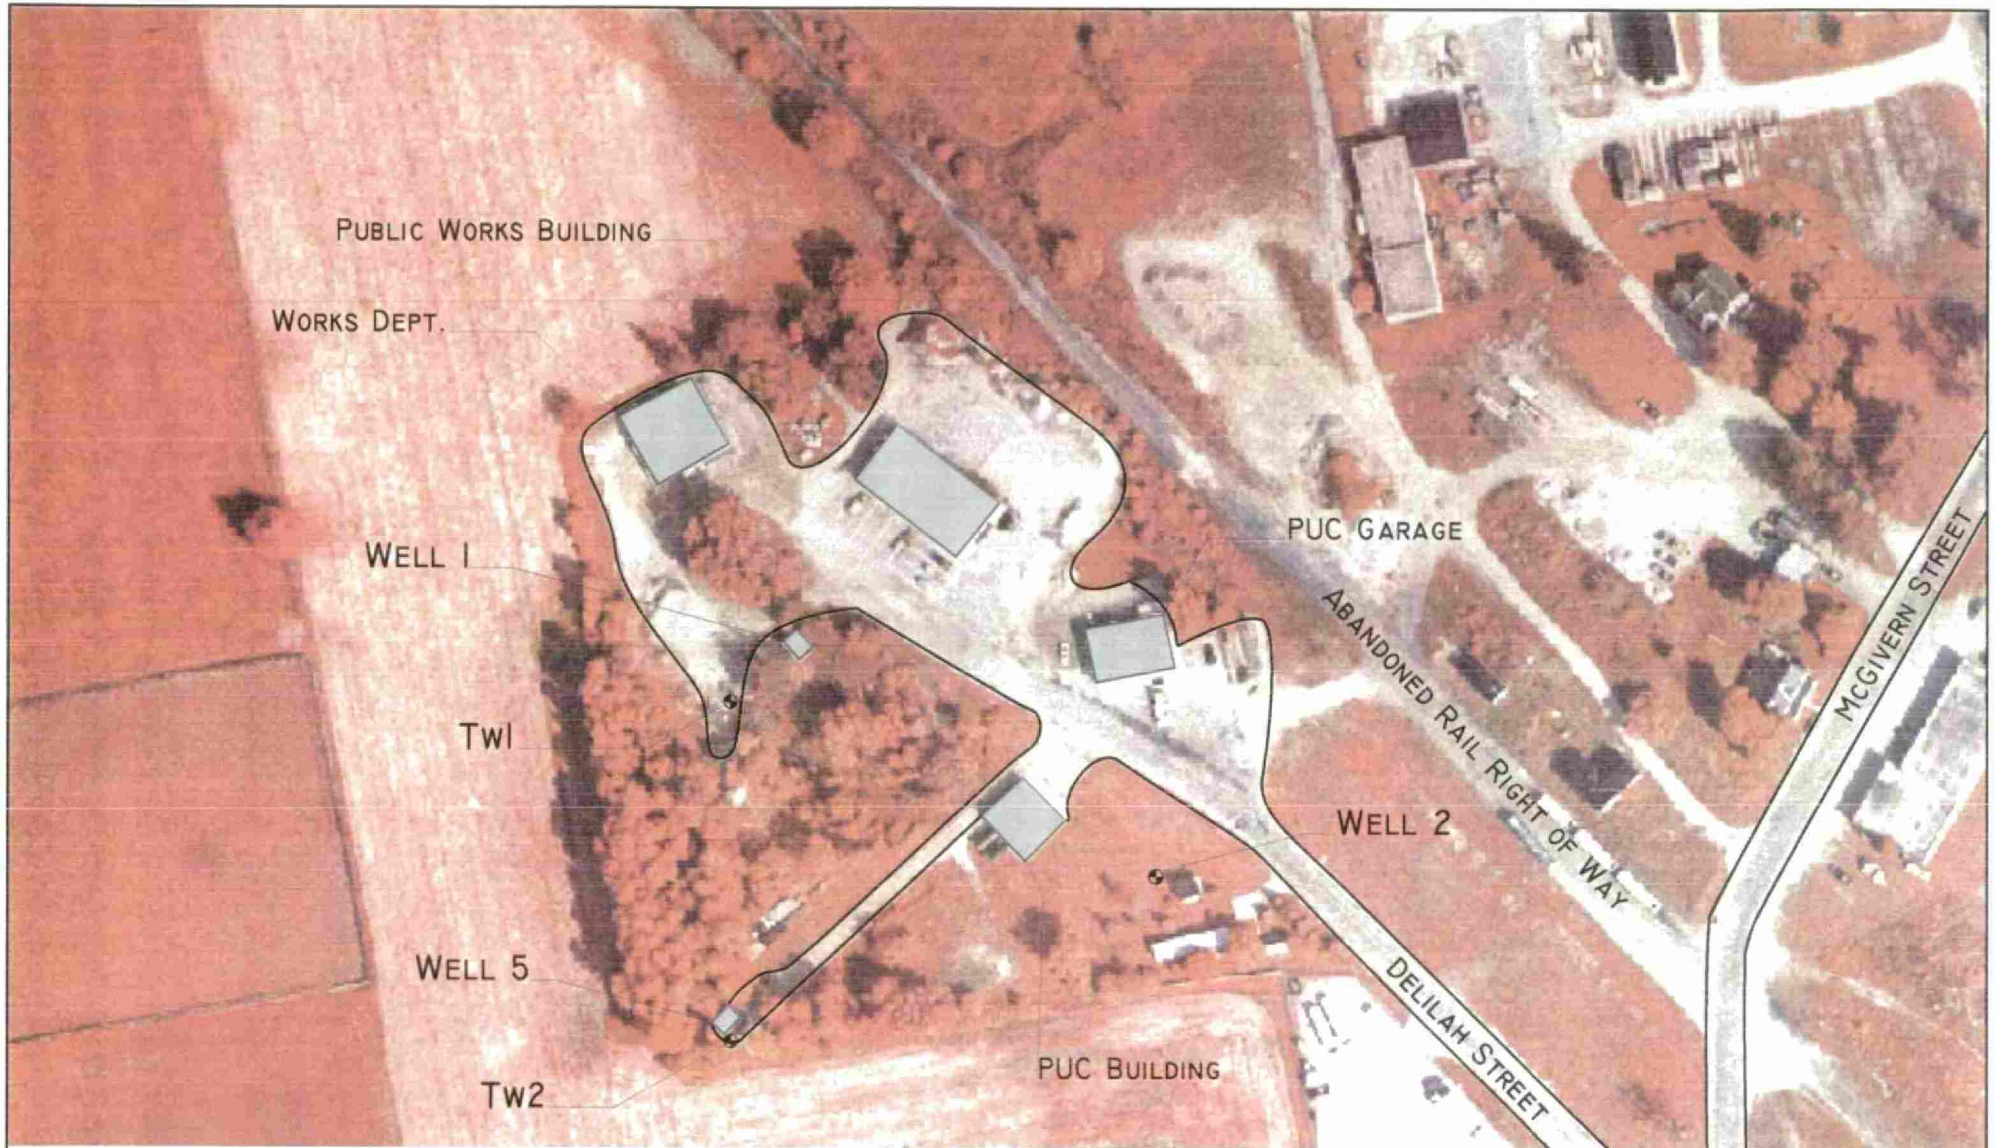
FIGURE 5

- Well 5 taps a shallow bedrock aquifer which is overlain by an overburden with a thickness of as little as 2.4 metres at the well site;
- Test Wells 1 and 2 (TW1 and TW2), located near Well 5, were found to be in a poor state of repair and represented potential entry points for contaminants from surface water to the supply aquifer ;
- Well 5 is located within a few metres of farm fields which are subject to fertilization with manure and the application of farm chemicals; and
- upon pumping the well, water ponded in the immediate area of the well was observed to rapidly infiltrate the ground, a nearby spring stopped flowing, and water flow from the spring reversed back into the spring.

Based on its investigations, Golder concluded that the shallow aquifer tapped by Well 5 at this location could not be made adequately secure and should no longer be used as a source of public supply. Golder also stated that, in its opinion, Well 5 was not secure, nor could it be made adequately secure, from potential impacts. As a result, Golder recommended that Well 5 be properly plugged and abandoned. Test Wells 1 and 2 were also plugged and abandoned in accordance with Ministry guidelines, at Golder's direction.

As part of the overall work to secure Walkerton's water supply, the Ministry will require that Well 5 be abandoned and plugged in accordance with Ministry guidelines and O. Reg. 903.

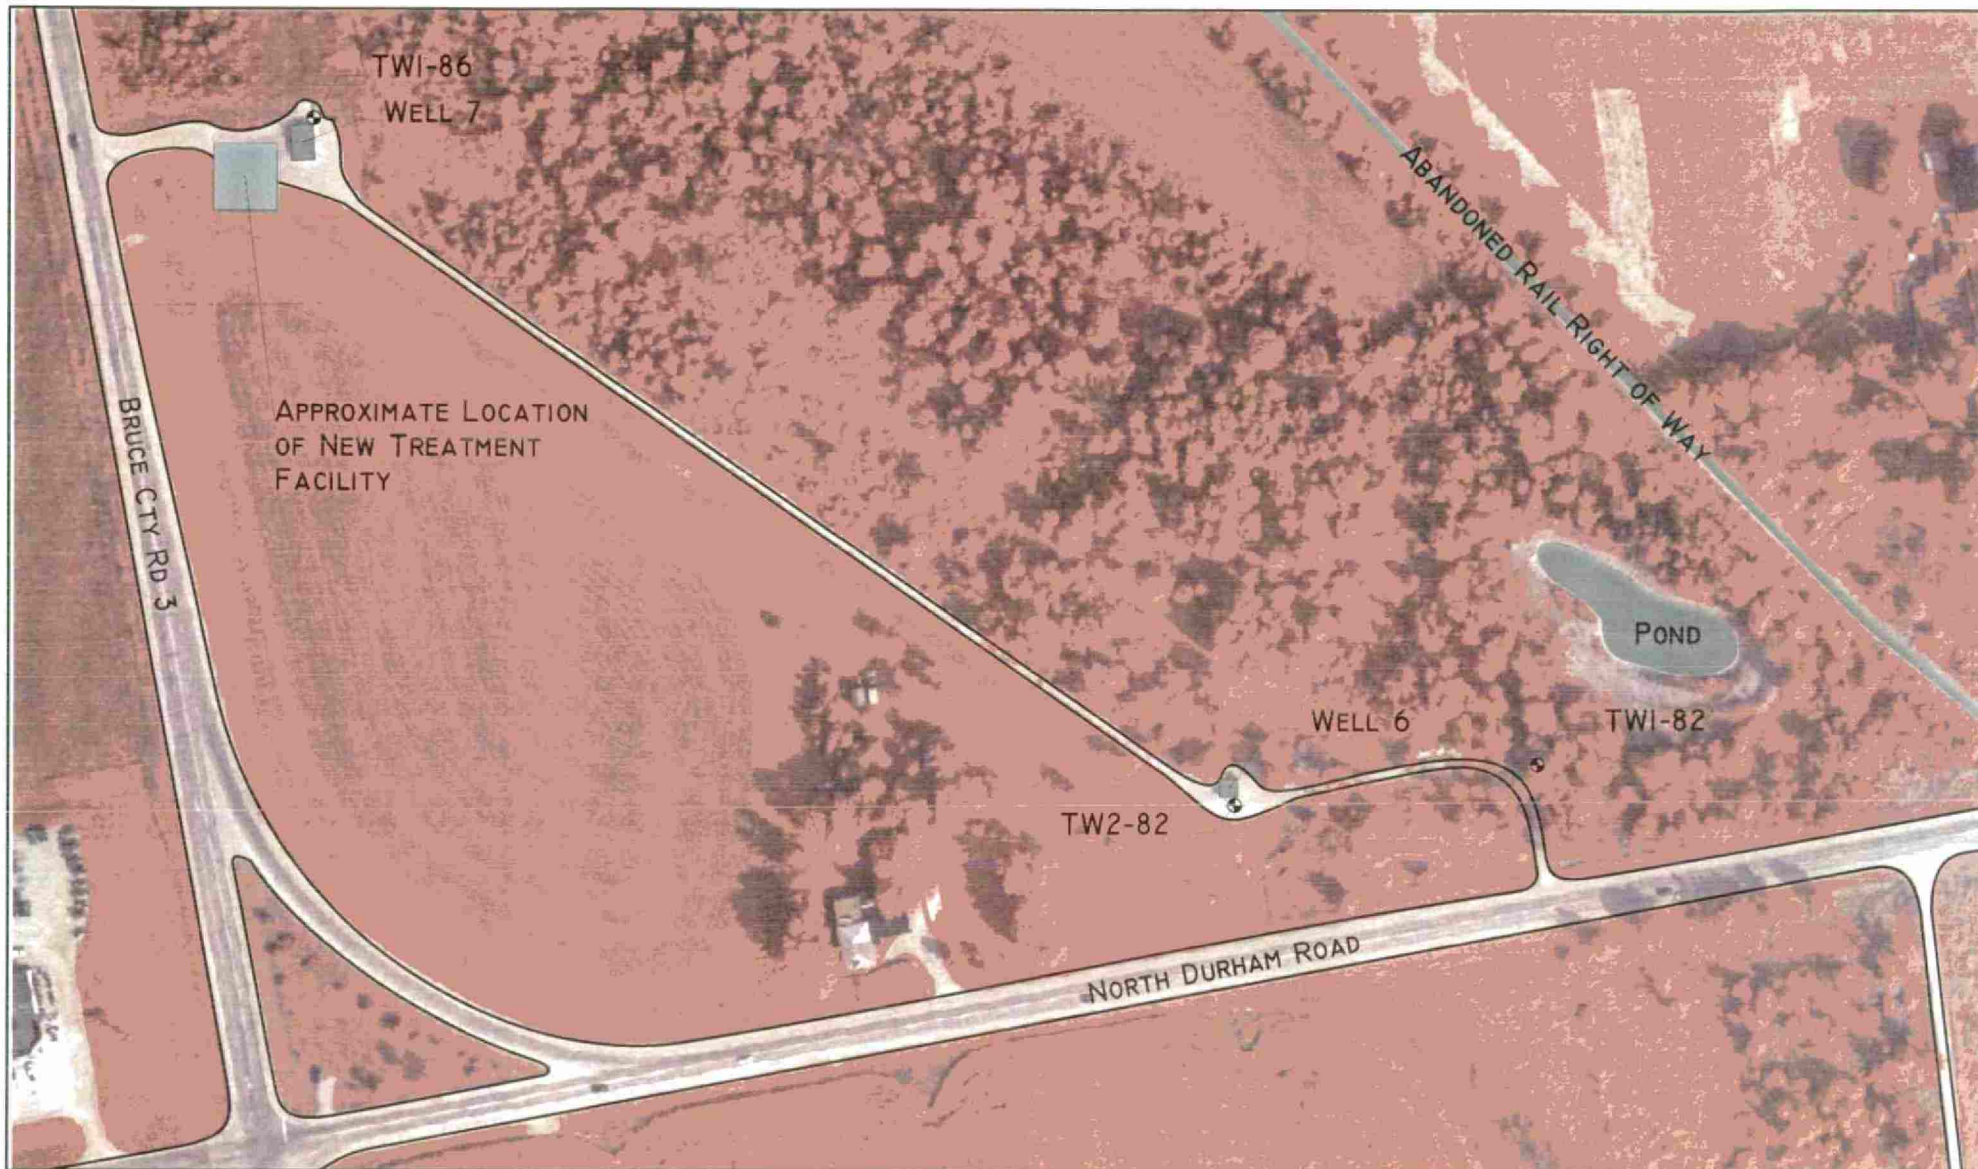
FIGURE 6

- Well 6 (see Figure 6) obtains water from seven different producing zones, with half its water coming from a depth of 19.2 metres;
- the chemical quality of the water is generally good, but varies with depth;
- elevated nitrate levels and hardness, as well as variable iron and turbidity were observed;
- with one exception, bacteriological analysis indicated no contamination of these water producing zones at the time of sampling; and
- there are four fabricated penetrations (holes) in the well casing within 1.25 metres of the base plate at the top of the casing.

- the casing penetrations be investigated and plugged;
- down hole testing be carried out to determine which water producing zones are more directly hydraulically connected to surface water;
- the Well 6 casing be extended to seal off the shallow fractures that are hydraulically connected to surface water; and
- the Municipality establish a well head protection area (WHPA) around the well field and develop appropriate land use management practices for the long-term protection of both the WHPA and the catchment area to protect the well's water supply.

The Ministry will require that the Municipality develop and implement a well head protection program in the well field area and conduct appropriate repairs/rehabilitation to Well 6 and its nearby test wells TW1-82 and TW2-82.

The Ministry recommends that the pond identified as being hydraulically connected to the water producing zones of Well 6 be filled with material of low permeability.
